BULGARIAN FIGHTER COLOURS 1919–1948

Vol. 1

Rainbow No 9136

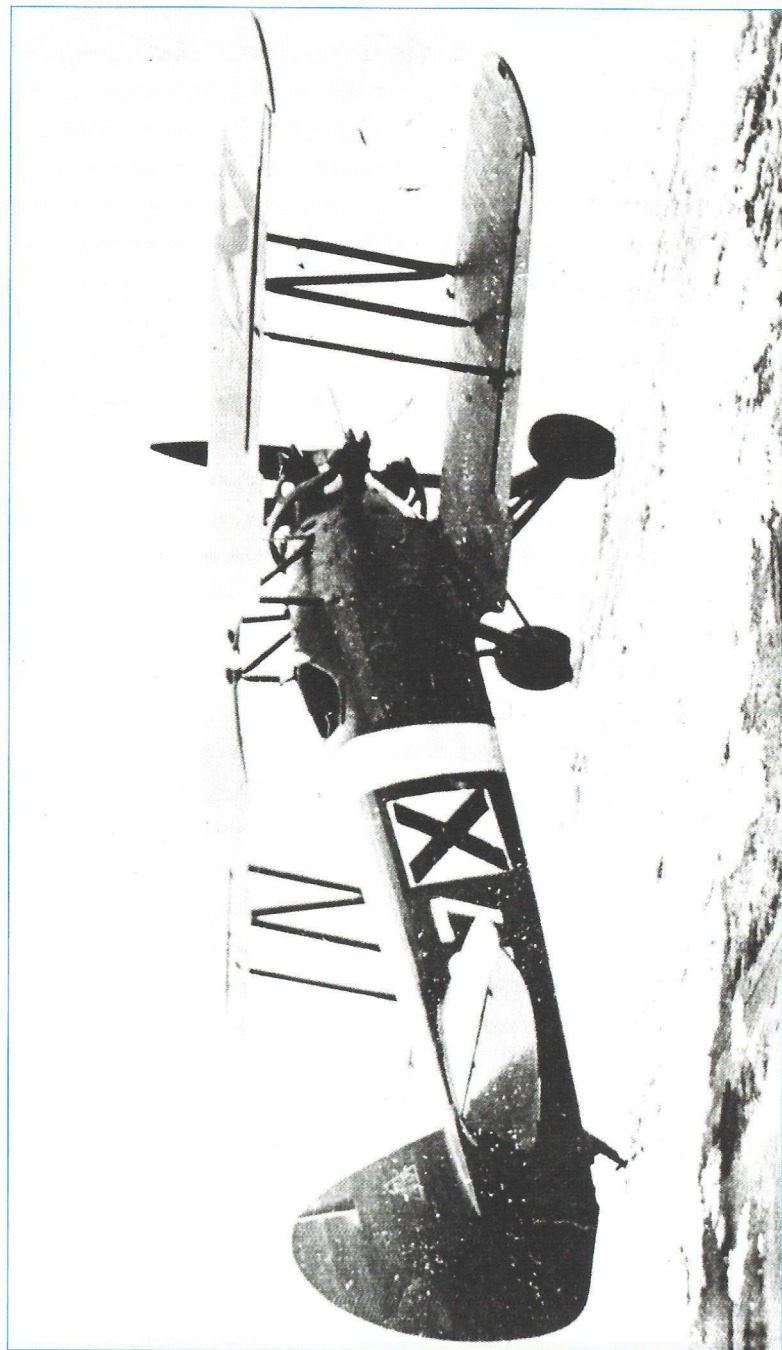
Avia Bš.122, 'White 27', 27/7013, Kuriersko Yato, 3/6. Iztrebiteľen Orlyak, Bozhurishte, February 1945. Camouflage colours: Dark Green upper surfaces, Light Blue under surfaces. Cross-style national marking in six positions. White mid-fuselage band, as well as upper and lower wingtips. White serial number on rear fuselage side.

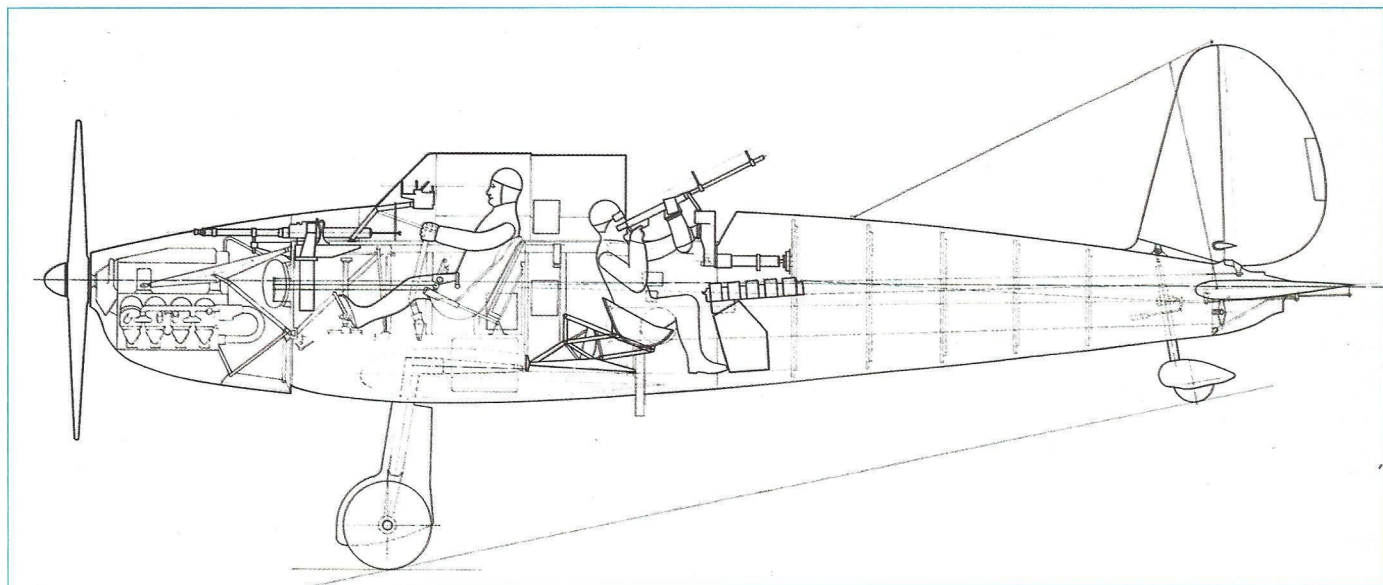
Detail factory photo of the rear gunner's stand, including the rearward firing MG 15 machine gun, mounted on a flexible lafette type K, Arado-style.

There was a receiver and transmitter radio set installed too. A visible detail related to the radio set is the belly antenna, used by the long wave length radio. When it was not used, it could be retracted into the fixed tube with a hand driven wheel by the rear gunner. The rear gunner's stand is visible on the factory detail photo (see above).

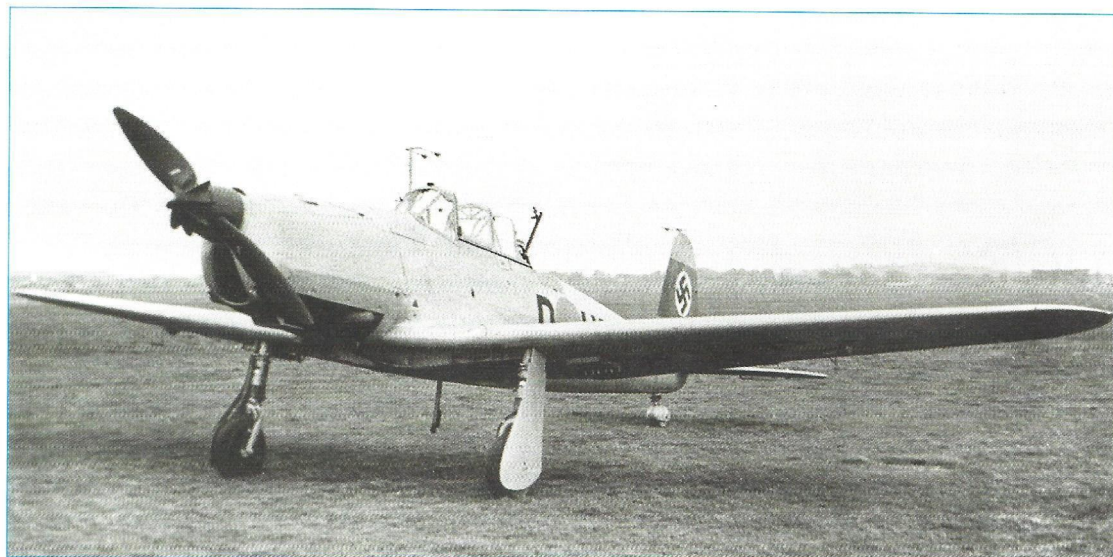
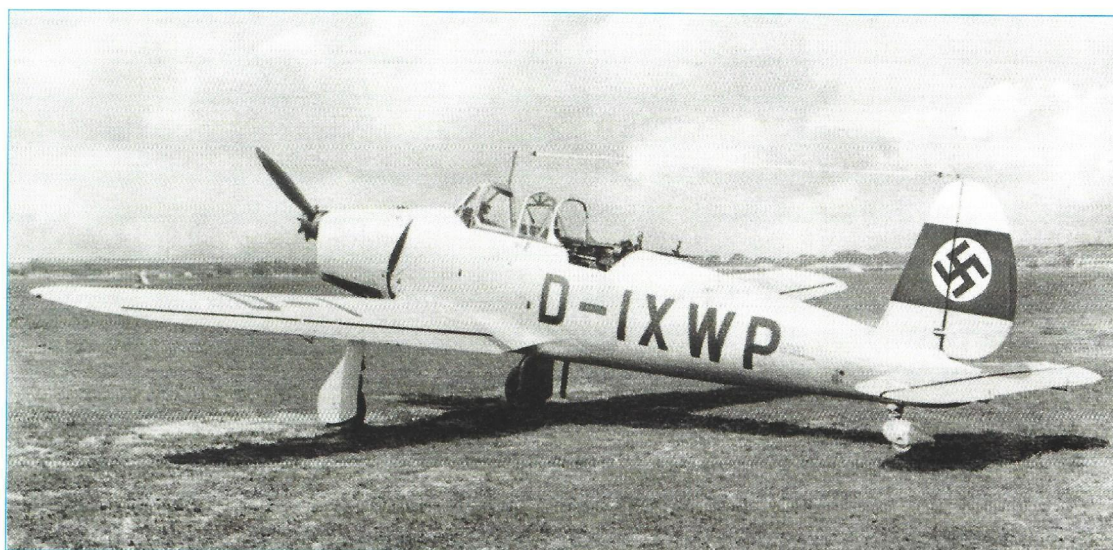
Two views of another Ar 96 B-1 (armed version) readied to be transferred to Bulgaria in late 1940. This particular one, D-IXWP, W.Nr. 960070, was the first unit of this peculiar version, being registered in Bulgaria as NN 1/7042. See page 234 for a couple of photos of this very aircraft, registered in Bulgaria as 'White 1'.

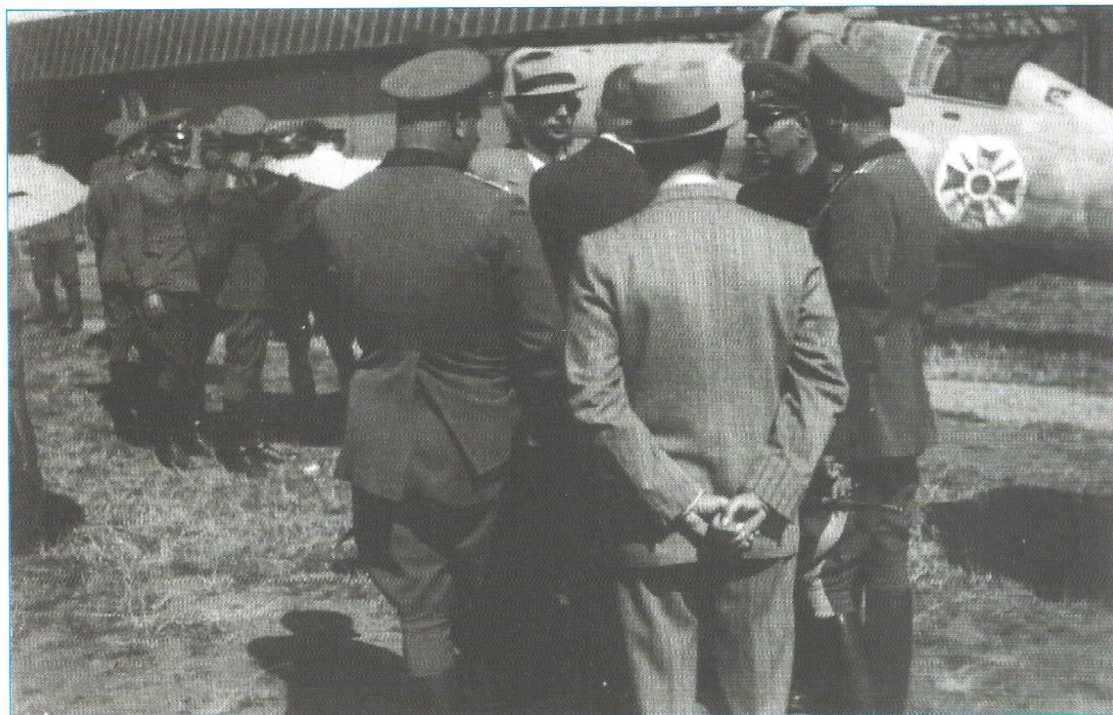
Low quality still that shows the arrival of the first unarmed Arado Ar 96B-1s to Bozhurishte airfield, in the autumn of 1940 (see also photos on page 243). Despite the poor quality, one can observe the overpainted German ferry markings on the fuselage, still retained on the wing upper surface. The washable paint was crudely removed from the fuselage, revealing the Tsar-type military roundel on the mid-fuselage. However, by the time the first Arados arrived in Bulgaria, this military marking was already obsolete.

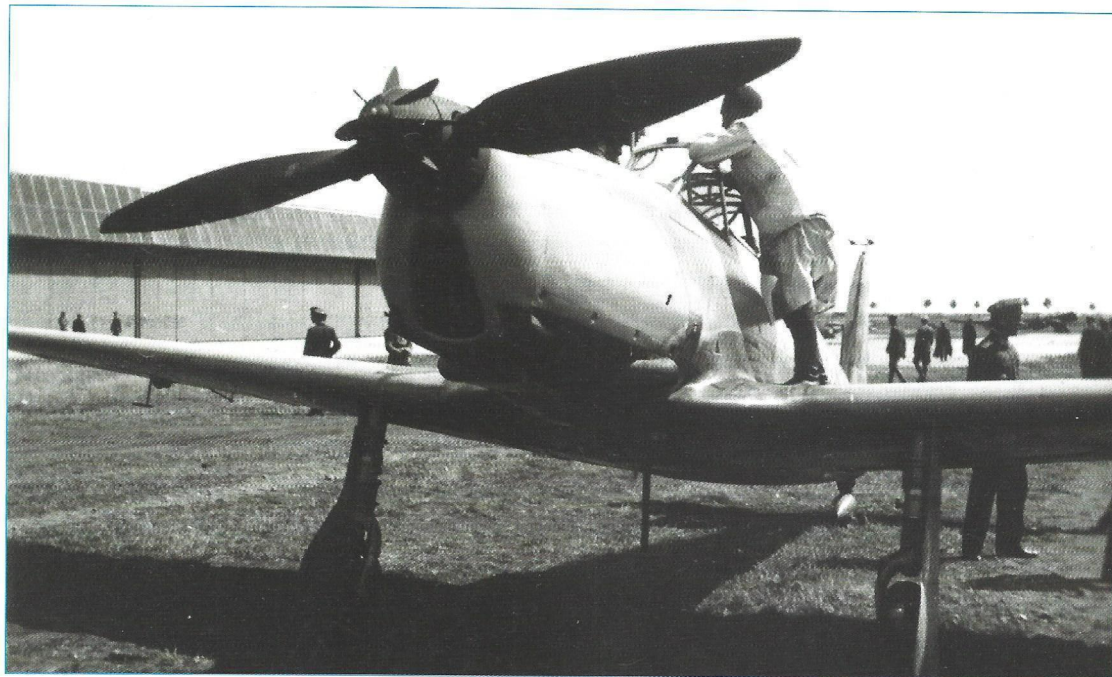
One of the first Arado trainers to arrive, with the temporary ferry civilian registration washed off the airframe, revealing the Bulgarian military marking on the mid-fuselage (barely seen behind the heels of the Bulgarian technician peering into the cockpit).

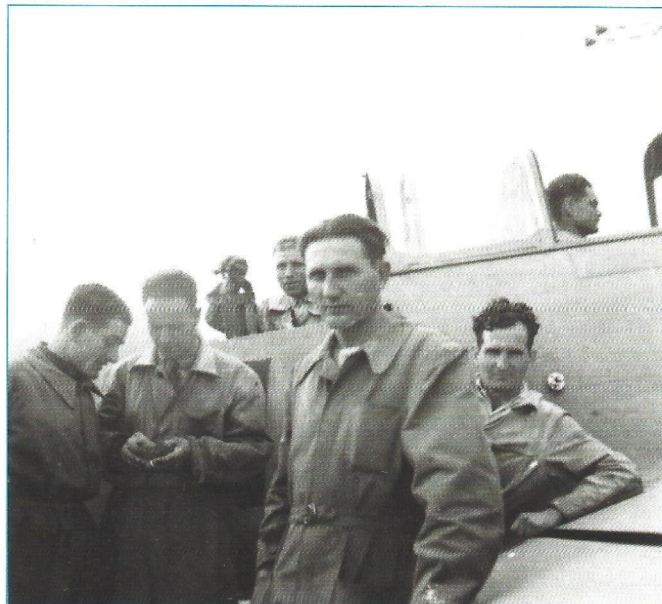
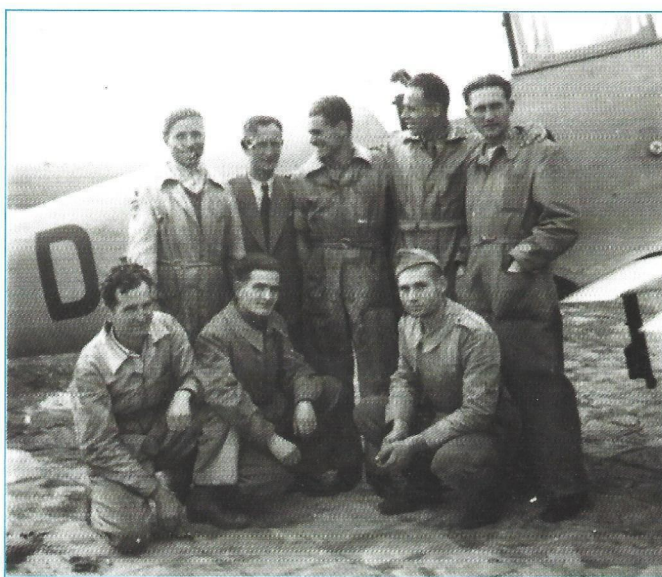
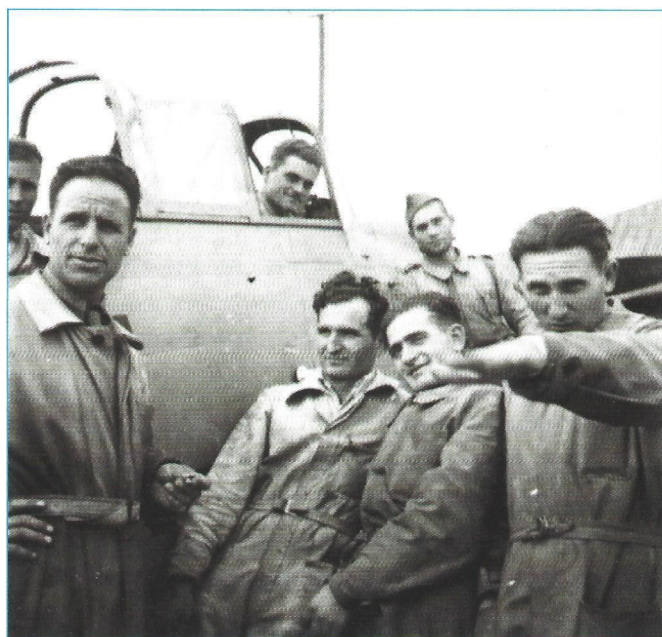
In this series of three photos Bulgarian ground crew flocks around the armed version of the Arado Ar 96B-1, just delivered to Bulgaria. The German civilian ferry registration is still retained on the airframe. Only four such aircraft arrived on their wings, Nos. 1, 2, 3 and 5, the rest were delivered by rail. The crewman in the rear cockpit rests his right hand on the rearward firing machine gun's lafette, Arado-style, type K.

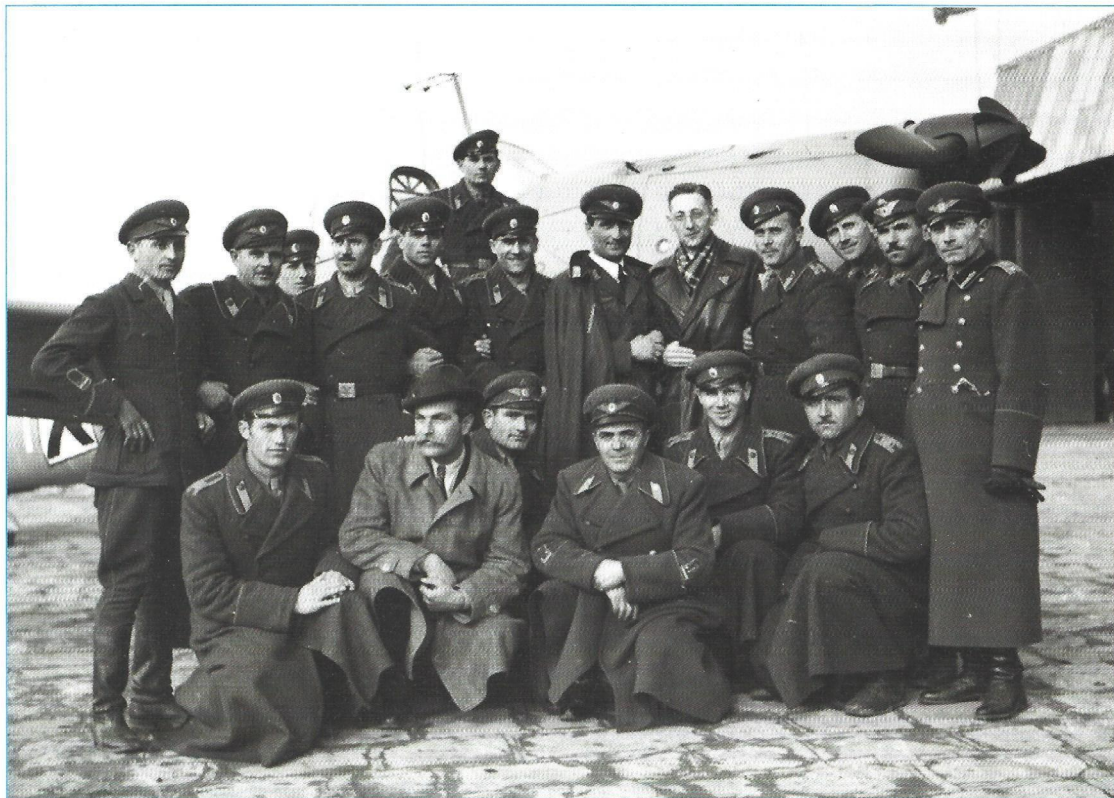
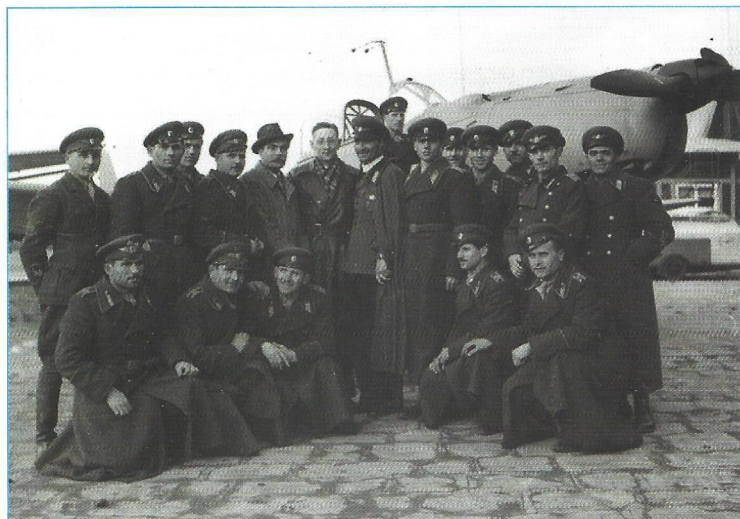
The first aircraft with rear gunner (White 1) was photographed on the tarmac of Bozhurishte airfield in early 1941. The civilian men are probably Arado employees. The nose mounted machine gun (as well as the rearward firing one), removed during the ferry flight over foreign countries, was not mounted yet. Interestingly, the aircraft's individual serial number on the fuselage was initially applied in white.

On the second, smaller photo, underneath the chin of the soldiers at left, a tiny surface of the white painted rudder can be seen. Some of the Bulgarian soldiers wear their ranks on the uniform's sleeves (technical officers), while others on the epau-

lettes (shoulder boards). One can differentiate the airmen from the army soldiers by the wings flanking and laurels surrounding the visor cap's oval badge, as well as the royal crown atop.

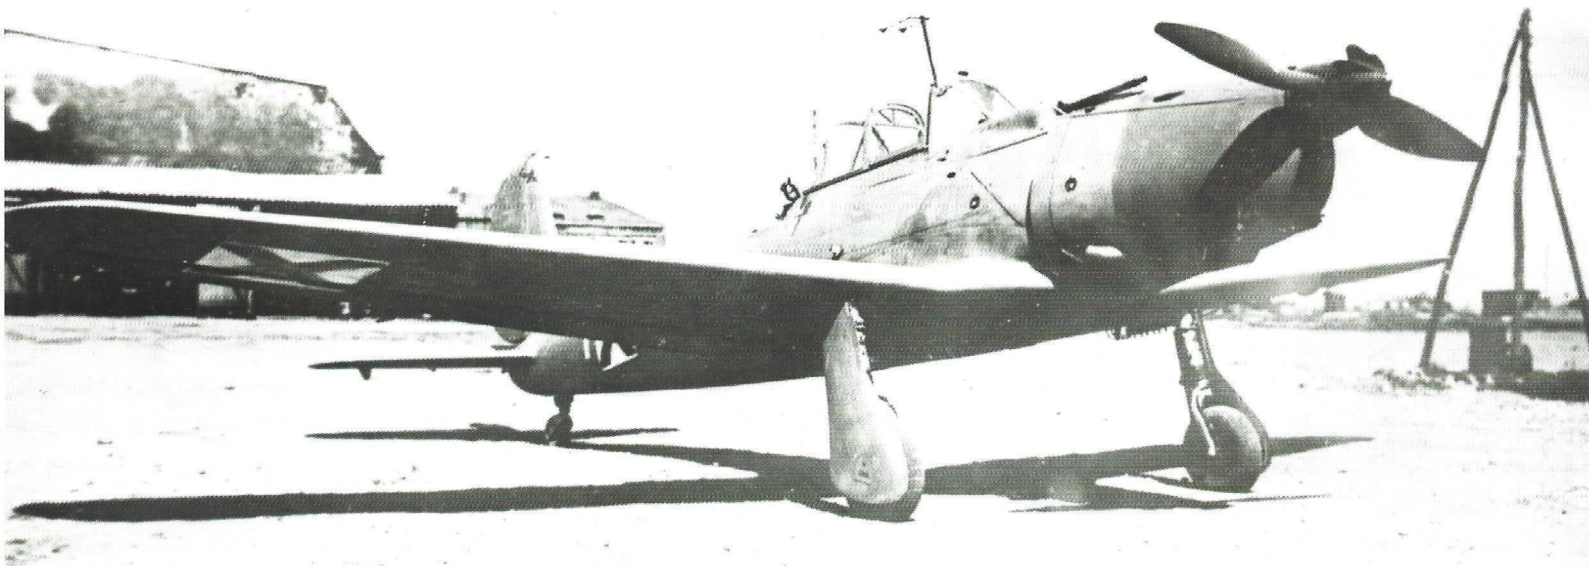
This general view of what appears to be the same 'White 1' depicted earlier shows the nose mounted MG 17 machine gun, as well as the ETC 50 bomb racks attached to the underside of the wings (see immediate left to the port undercarriage).

Two-thirds of the engine cowling is painted yellow, so is the rudder (and probably the elevators as well), however, there is no trace of the same Axis identification colour on the wingtips, or of a yellow band on the fuselage.

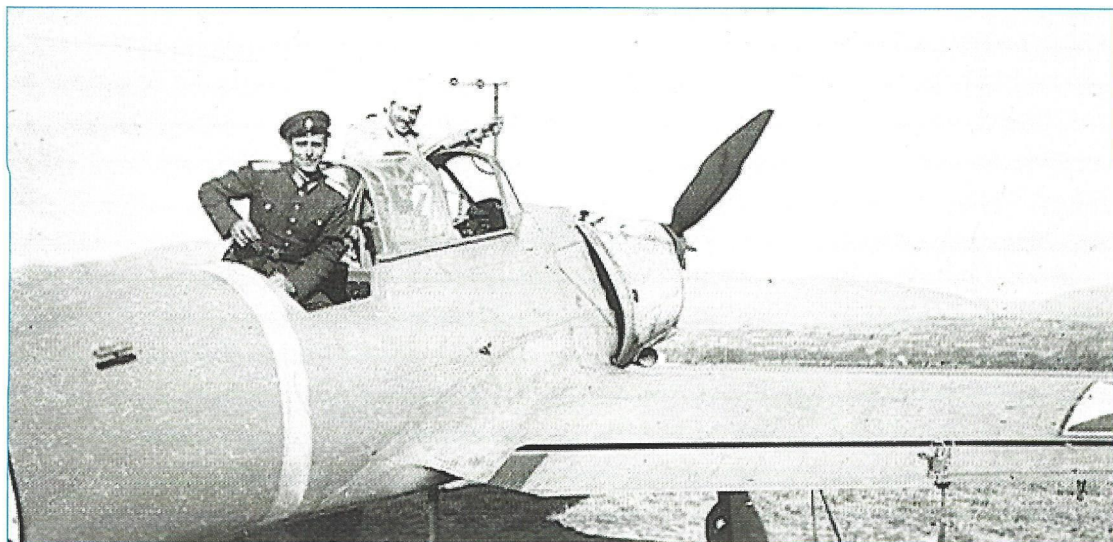
This armed Ar 96B-1 sports a thin, yellow mid-fuselage band. No similar band is visible on the wing, though. The engine cowling also appears to be painted in yellow (but not the spinner). Photo taken in, or shortly after, April 1941.

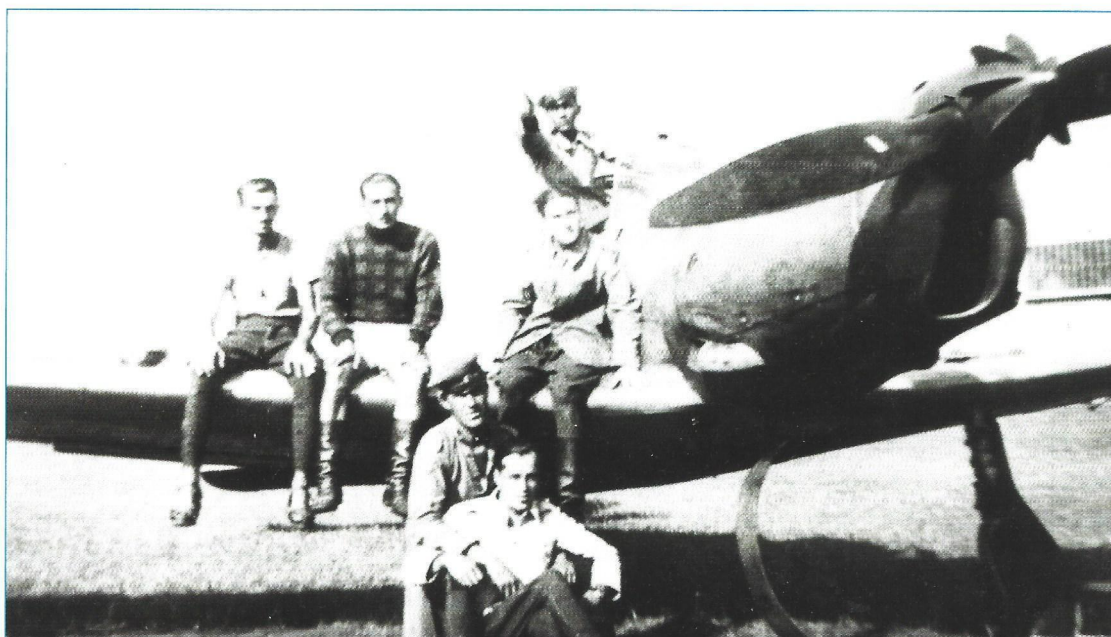
The soldier casually sitting on the front starboard cockpit side wall points to an approaching aircraft; however, the others appear to be indifferent to his warning. This particular Soyka has its engine cowling painted all around in a bright colour (probably red, or yellow), as well as was the rearward tapering fuselage flash – an ornament rarely seen on Soykas.

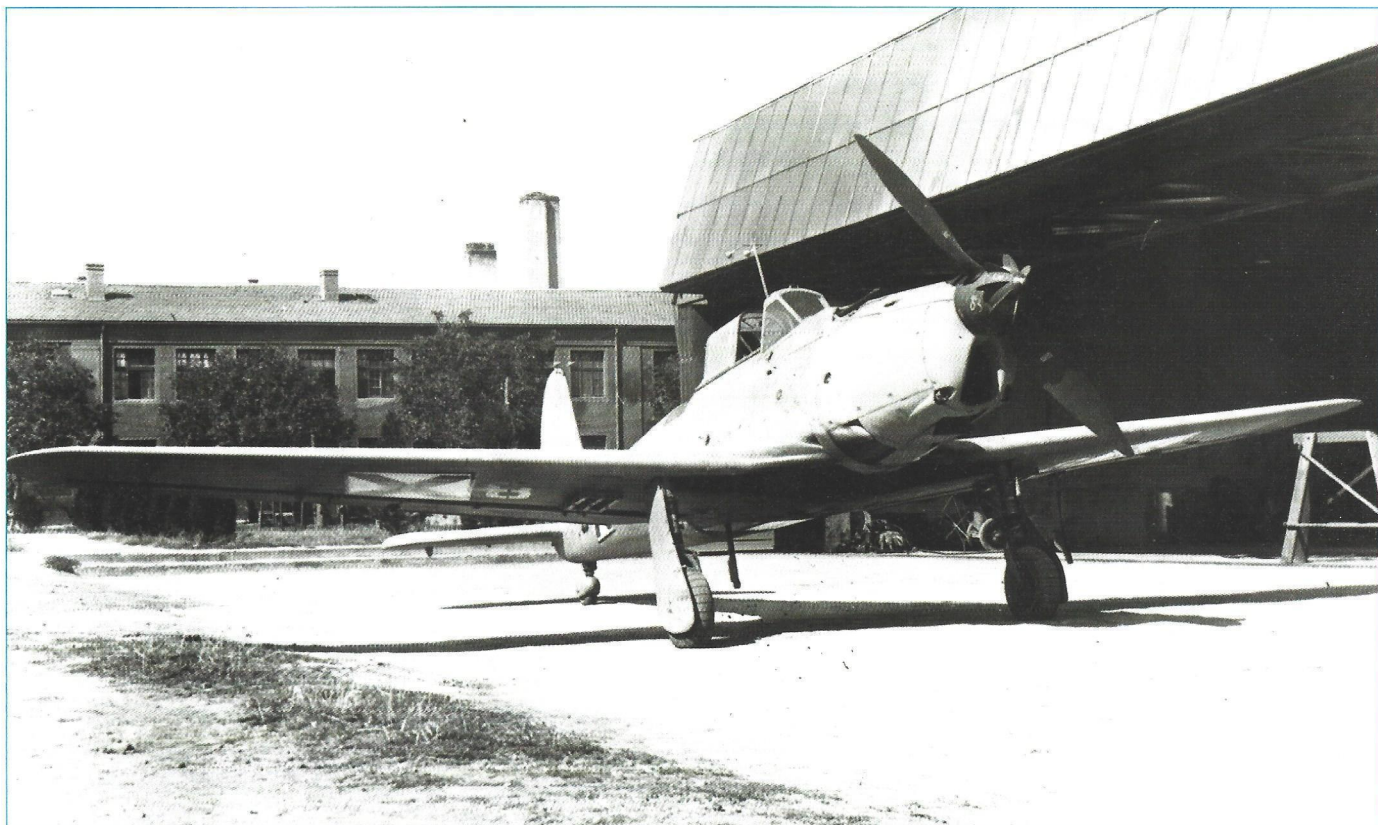
Another view of a Soyka, taken from about the same angle, as the one on page 233 top, shows 'Black 8', parked in front of a hangar. The bomb rack is well visible underneath the starboard wing. The lower wingtips appear to be painted in yellow, as was about 2/3rd of the engine cowling and possibly the rudder and elevators as well. The aircraft's individual number is applied on the fuselage, in black, as is on the lower wing surface. A rarely seen detail, typical to the Bulgarian version of the Ar 96B-1 with rear gunner, is the rectangle glass panel under the mid-fuselage, adjacent to the underbelly antenna mast. The number 83 chalked in white on the propeller cone and spinner represents the last two digits of the aircraft's construction number, W.Nr. 960083. Notice the 7.92 mm calibre MG 17 machine gun, mounted on the starboard side of the nose section, firing through the propeller arc.

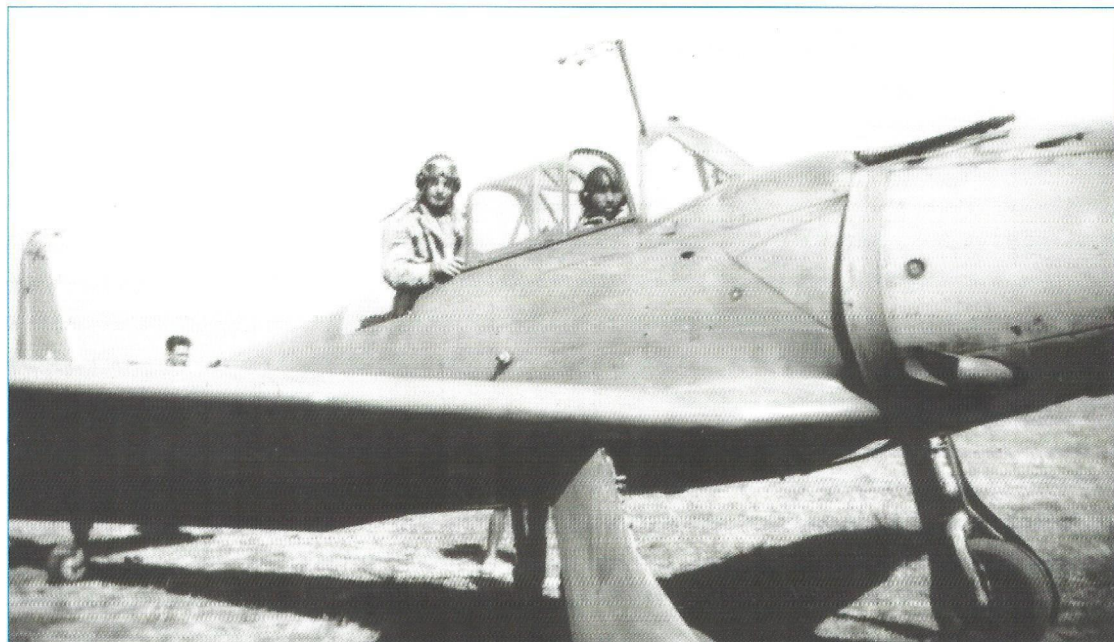
During the invasion of Yugoslavia by German troops in April 1941, a thin yellow band appeared on the mid-fuselage, often combined with a solid yellow engine cowling (either fully covered, or only the front 2/3rd area). Later, possibly from 1943 on, both surfaces of the wingtips became yellow as well, alongside the rudder and elevators. About ten days following Bulgaria's about-face and defection from the Axis camp on 9 September 1944, all 'Axis-yellow' paint was removed, and replaced with a white rear fuselage band, the same colour covering both surfaces of the wingtips.

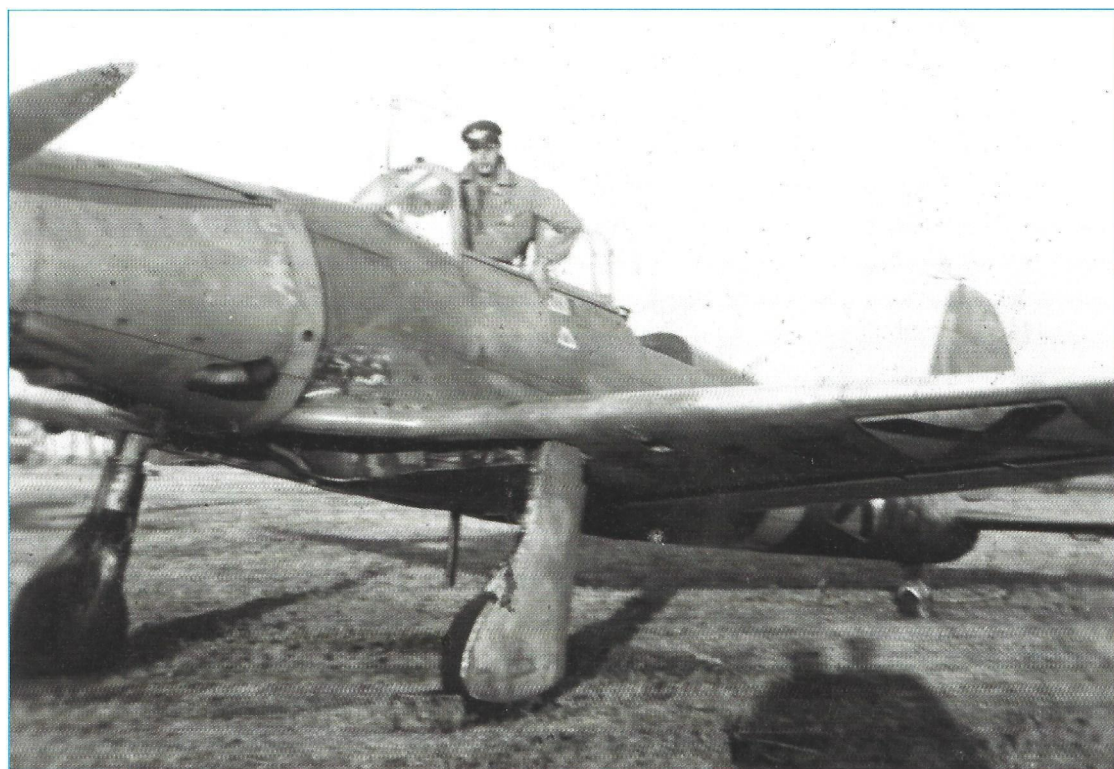
Depending on the colour of the mid-fuselage band, the photo was taken either during the pro-Axis time period, prior to September 1944 (in this case the colour is yellow), or post that crucial date (the colour is then white). Chances are that the band was white, as wide yellow fuselage rings were used on VNV aircraft only seldomly. Unfortunately, the wingtips are not visible, those would have clarified the question. The aircraft's individual serial (board) number, applied in black on the rear fuselage and on the underwing surface, is 18. The outer segment of the port wing appears to be painted in the typical Bulgarian light grey, which was a bit of lighter shade than the original RLM 02 RLM-Grey. No. 18 was officially scrapped on 18.04.1947, so it soldiered throughout the war and beyond.

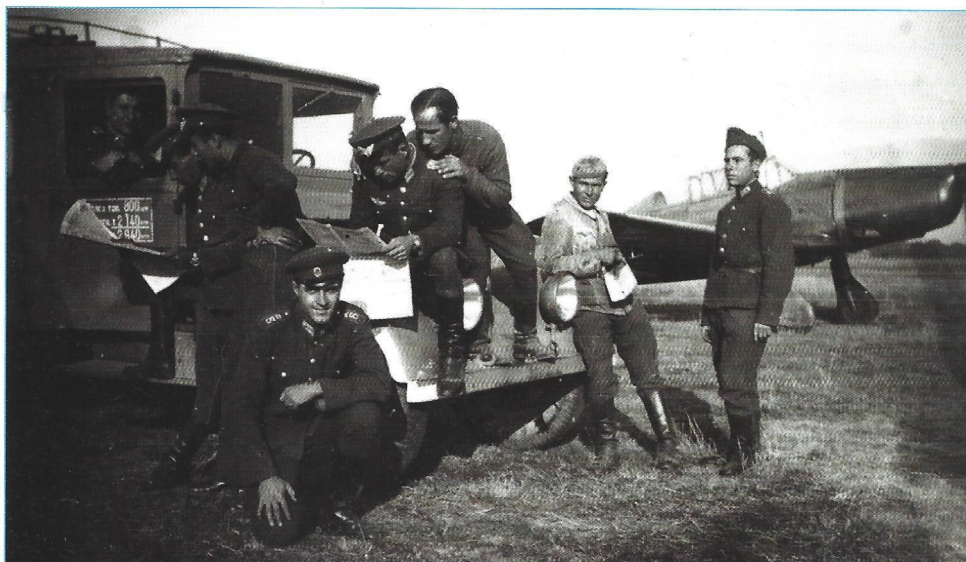
In this particular case, the Ar 96B-1 wears yellow wraparound engine cowling and both the lower and upper surfaces of the wingtips are yellow. Presumably, the rudder and elevators are yellow as well. The airmen, identifiable by the wings on their visor cap and by the wings embroidered over the right pocket of their uniforms, are busy reading the newspaper, and only the kneeling army man pays attention to the photographer. This 'civilian' (i.e. unarmed) trainer was photographed on Karlovo airfield, in October 1943.

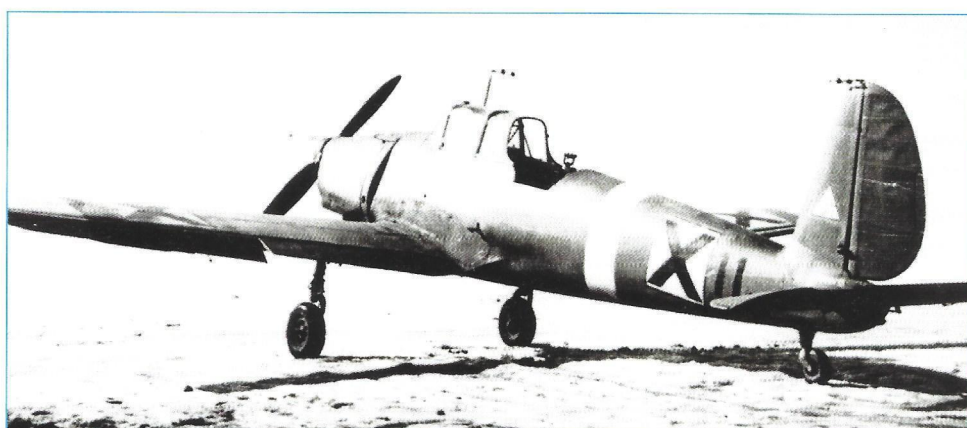
The photo of 'Black 11' was undoubtedly taken after Bulgaria's early September 1944 about-face, as identified by the white fuselage band, upper wingtips and spinner. The Nomenklaturen Nomer (NN, i.e. Register Number) of this variant with rear gunner, 7042, is clearly visible in the bottom row of the triangle applied on mid-fin, while the aircraft's individual serial number, 11, was written in the top row. Due to dark appearance of the greenish-grey variant of the RLM 02, most artists have mistaken this colour to dark green, and drew their profiles accordingly – erroneously. Often, the rear fuselage band and wingtips are depicted yellow, which again is an error.

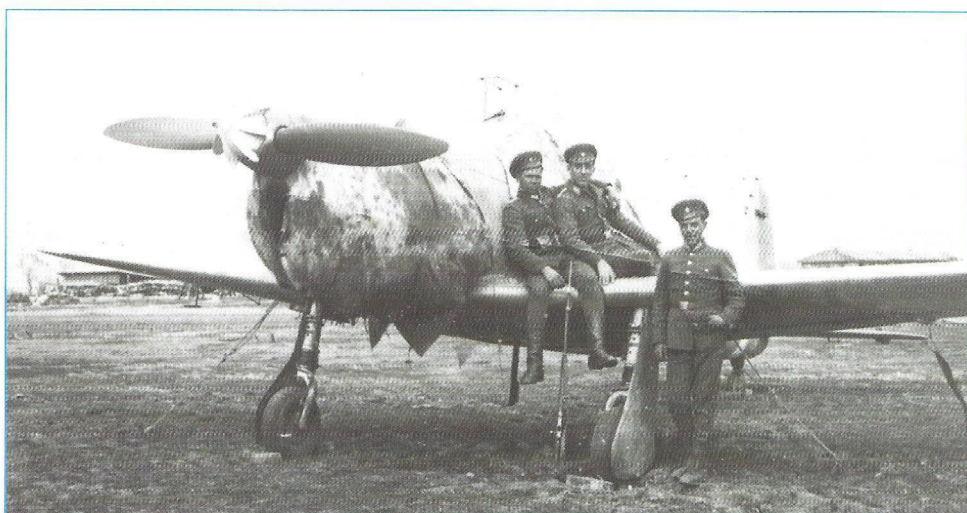
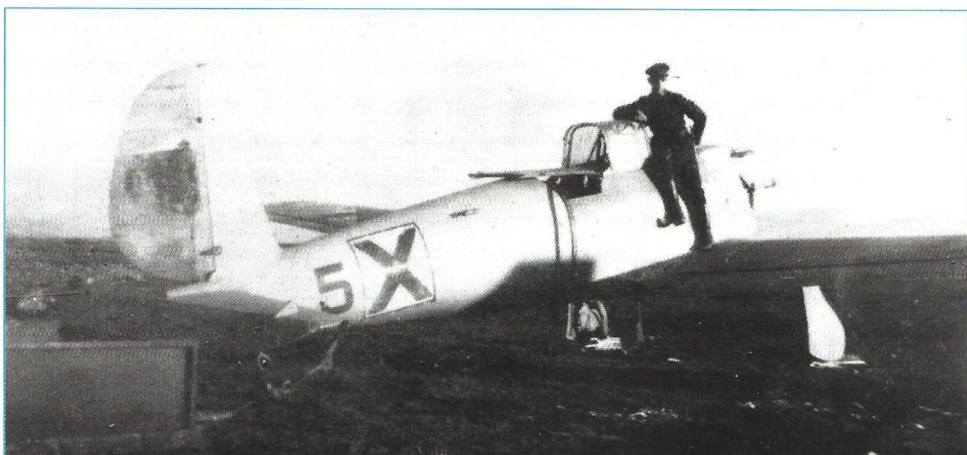
Two photos depicting derelict Soykas in 1947, photographed by one of the soldiers assigned to guard the airfield. Worth noticing how the yellow coat of paint faded away on the rudder of the engineless No. 5. This phenomenon reveals the Bulgarian tricolour, which, in turn, also faded, revealing the original German marking underneath, consisting of a red horizontal band with a white dot in centre and a black swastika inscribed in it.

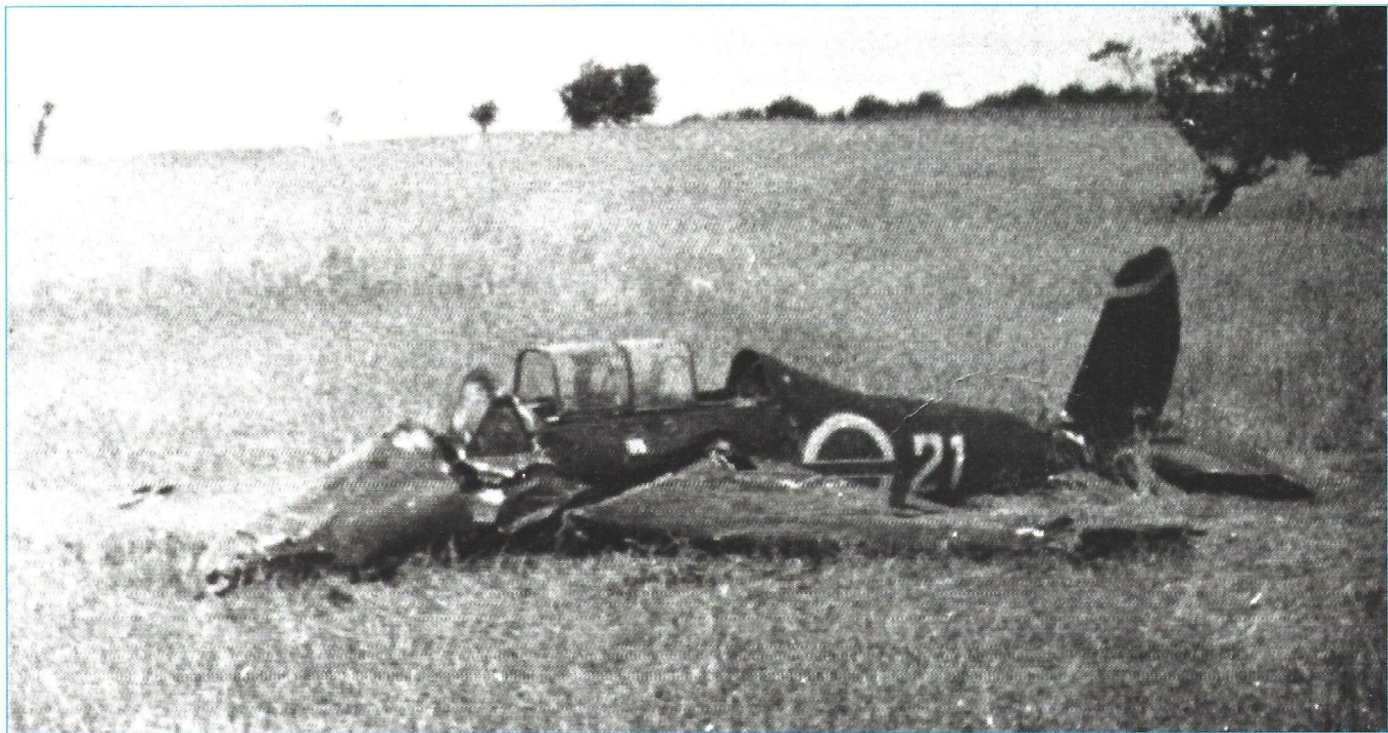
On 4 October 1945, the Axis style 'Black X in White Square' type military marking gave way to a new one, closely connected to the ruling pro-Communist party, the Otechestven Front, or Fatherland Front (abbreviated OF). This particular incident happened long after that marking change, namely on 26 May 1950. It involved Soyka No. 21/7035, of the Telish based piloting school. Luckily, the aircraft's original construction number is given in the post-accident report, W.Nr. 55 0448 (formerly GM+VN). This identifies the aircraft as a Letov-built B-7, produced sometimes in late Summer of 1944, which was then captured by Soviet troops at Zeltweg airfield in Austria, and subsequently handed over to the Bulgarians in mid-1945, being part of the official figure of 19 such 'trophy' Ar 96s. Unfortunately, both crewmembers died in this accident, which most probably represented only the second deadly incident that involved an Arado Ar 96 during the approximately fifteen years of service in the Bulgarian air force – an enviable record by any standards.

The second and last fatal accident involving a Bulgarian Ar 96 happened as late as 26 May 1950. That day, during a regular training flight, the worn engine of Ar 96B-7, No. 21, stopped in mid-flight, at 150 m altitude. The aircraft then stalled and crashed near Rakita. Unfortunately, both crewmembers, *Uchenik letets mladshi kursant* (Student airman junior cadet) Hristo T. Gramatkov and instructor *Podpor.* (2nd Lt.) Slavcho S. Slavchev, were killed. The doomed *Soyka*, impressed in Bulgarian service on 17.08.1945 (thus a 'trophy' aircraft), was a total write-off (see photo and artwork on page 250).

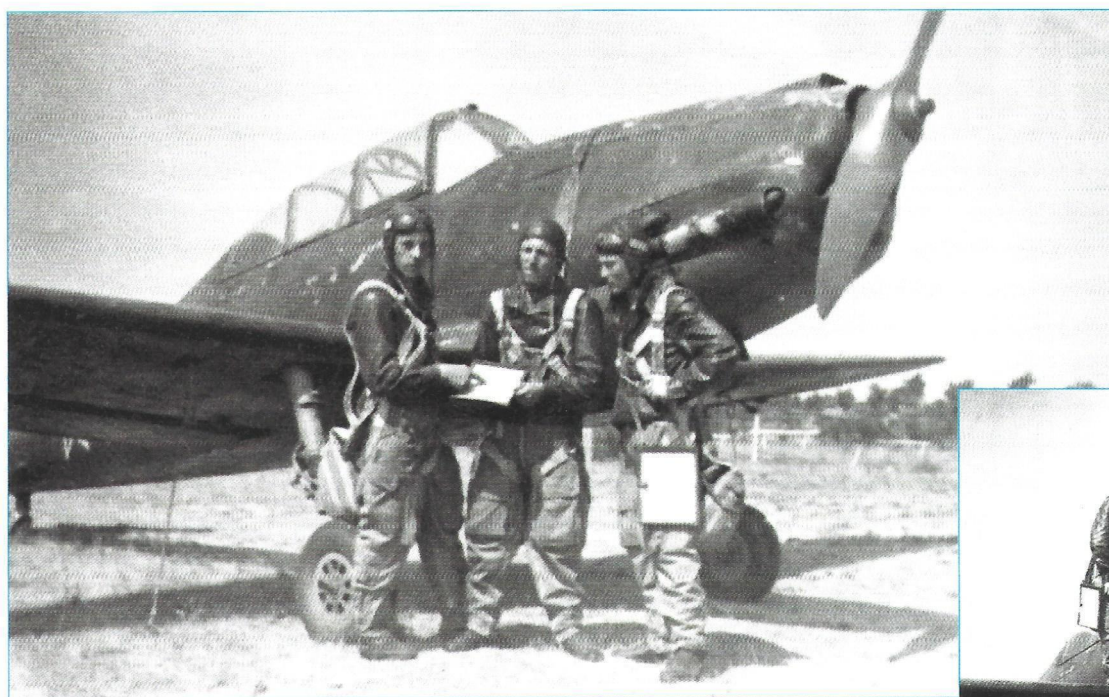
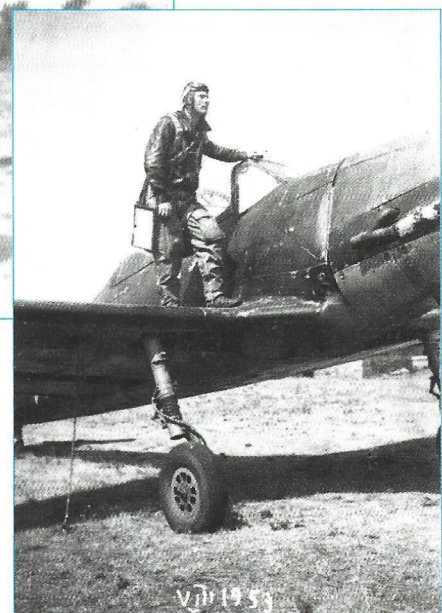
Judging by the identical paint chip-off seen on the exhaust pipe, both photos (top and left) show the same aircraft. Highly interestingly, this is not a 'regular' 'Berta', but an early 'Anton' Bulgaria officially never received from Germany! Therefore, it can be assumed that it is one of the so-called 'trophy' aircraft recovered in Austria immediately after the war's end with the Soviets' consent. It could very well be an ex-Hungarian air force machine, which retreated to Austria in early 1945, then was abandoned there, just to be recovered by Bulgarian technicians. Also uniquely among surviving photographic images of Bulgarian Arado 96s, the aircraft sports the Communist style red star on the fuselage. This is explained by the date written on the bottom of one of the photos, August 1953.

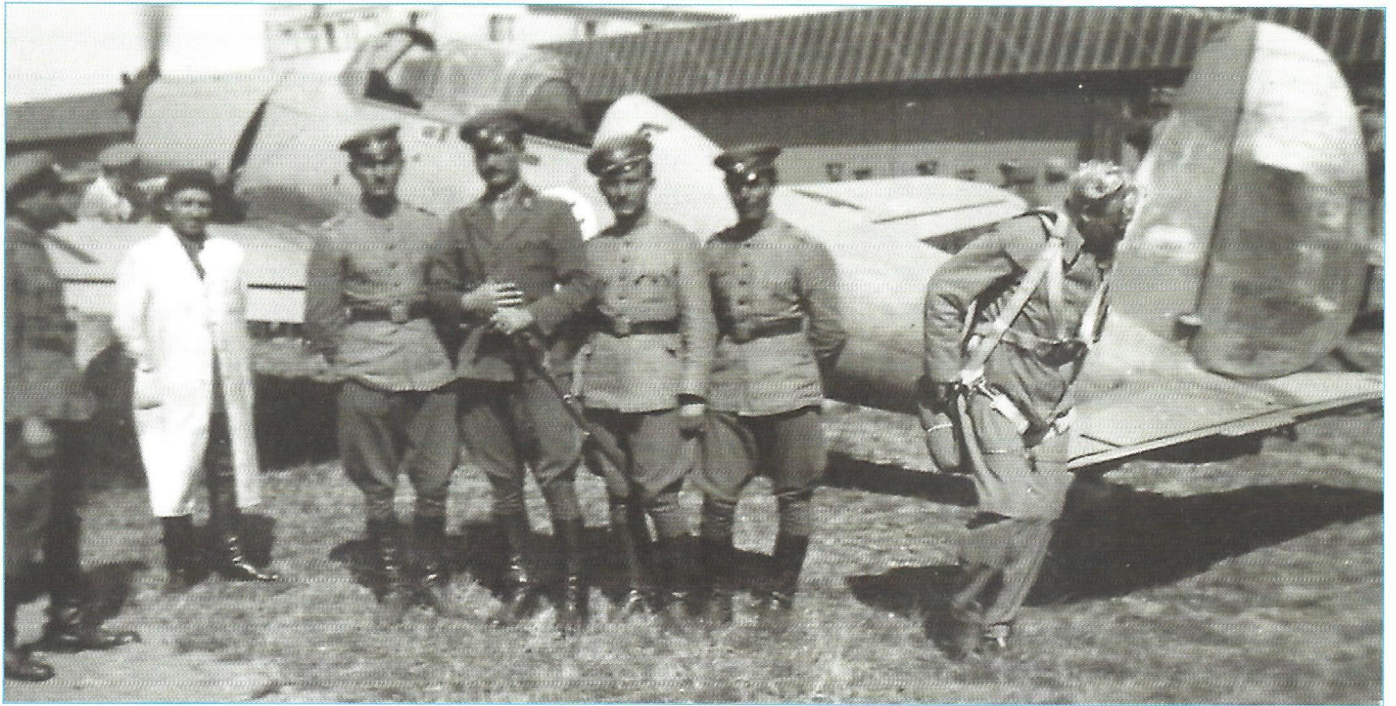
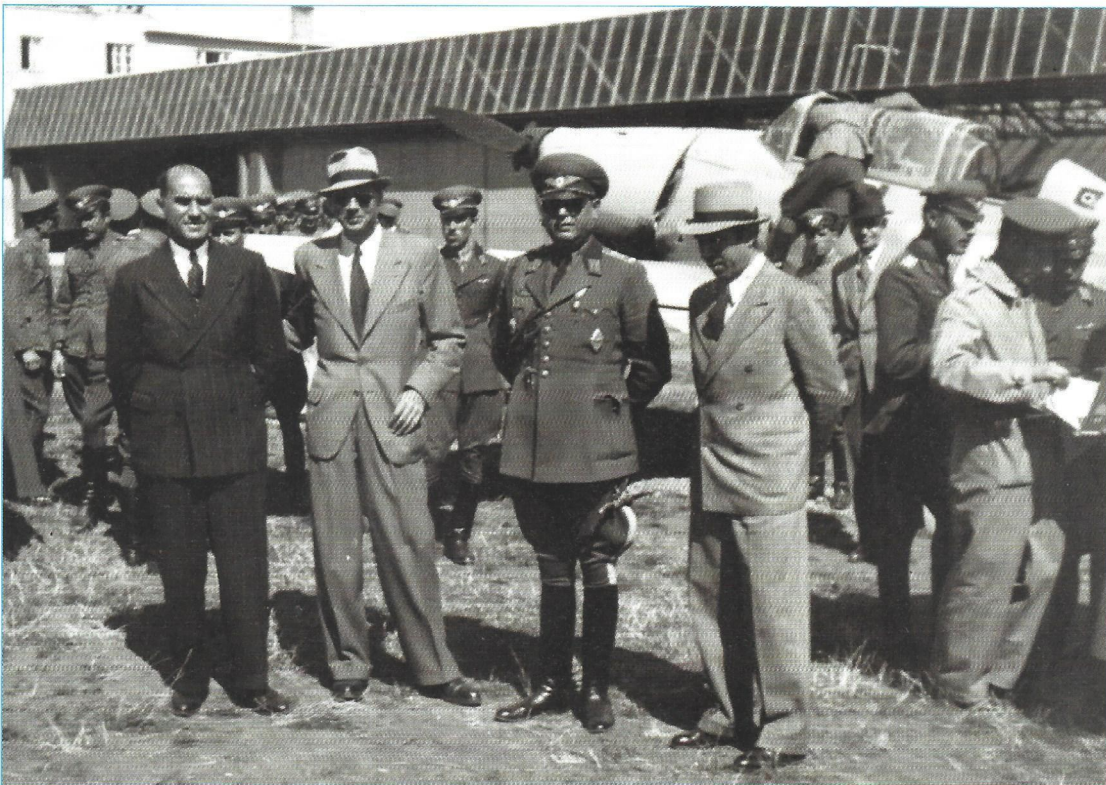
These photos were taken immediately after the batch of four unarmed, all-grey Ar 96B-1s had landed on Bozhurishte main airfield in September 1940. Notice the black German civilian ferry markings visible on the starboard wing (...WA), which identifies this particular ship as the first Ar 96B-1, D-IXWA, W.Nr. 96 0060 (future NN 1/7035 in Bulgarian service). Also note the overpainted Bulgarian air force roundel close to the wingtip. The washable paint covering the military marking had already been removed from the fuselage. Notice the Bulgarian airplane seen in the background, at left, already sports on its wing the new 'black-St. Andrew-cross-in-white-square' type marking!

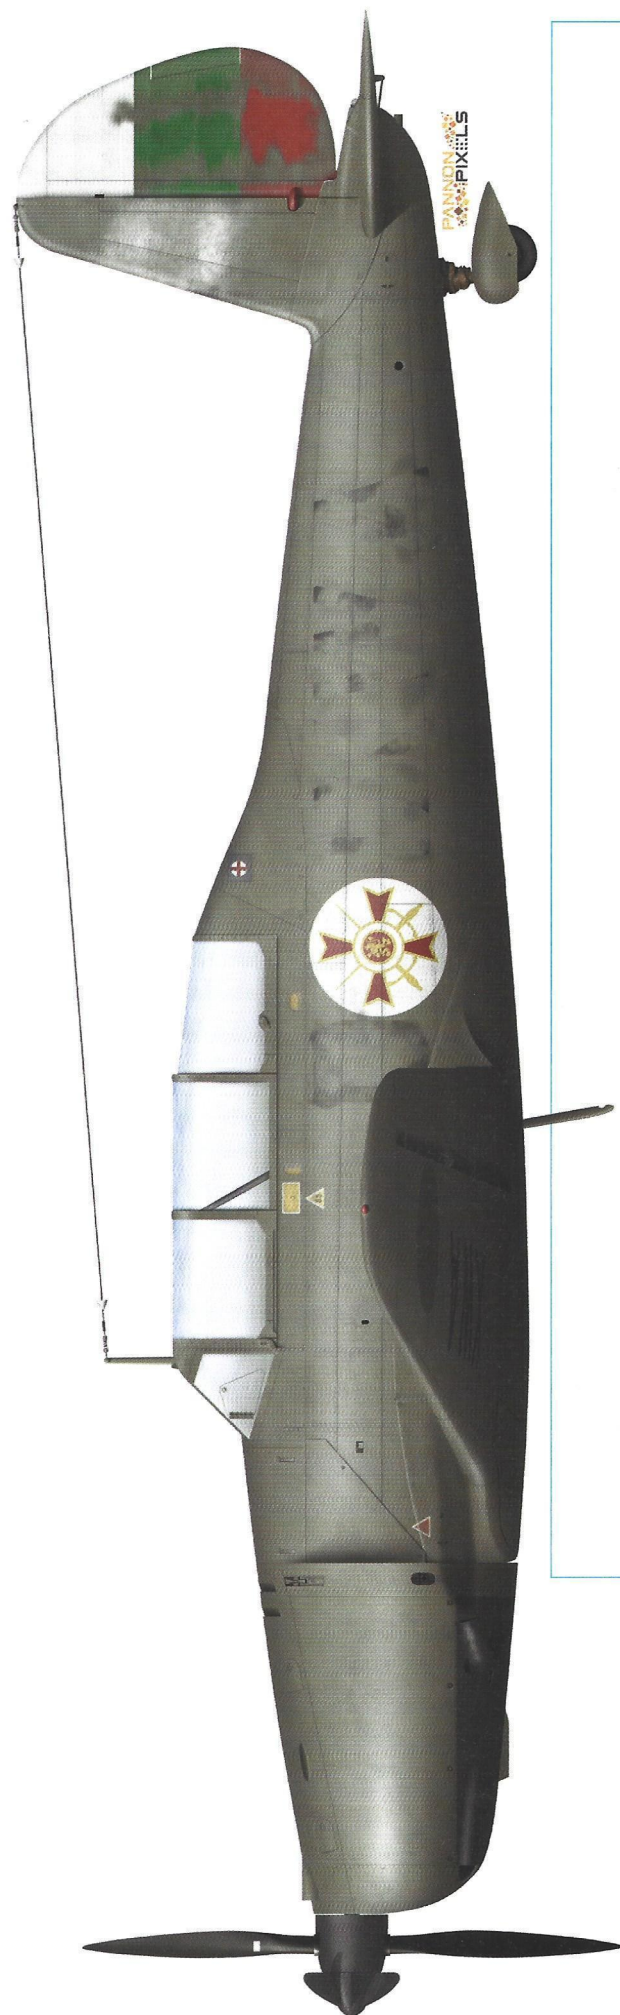
Arado Ar 96B-1, unarmed (WNr. 96 0060, ferry registration D-IXWA), 1/7035, Bozhurishte, September 1940. Camouflage colours: RLM-Grey (RLM 02) overall. Spinner and propeller blades black. Roundel style national marking in six positions (partially covered). Rudder in Bulgarian tricolour (White, Green, Red).
